TECHNICAL MEMORANDUM TM-2328-SHR

INVESTIGATION INTO ACRYLIC PAINT CRACKING (APC) ON ASPHALTIC PAVEMENTS

January 2000

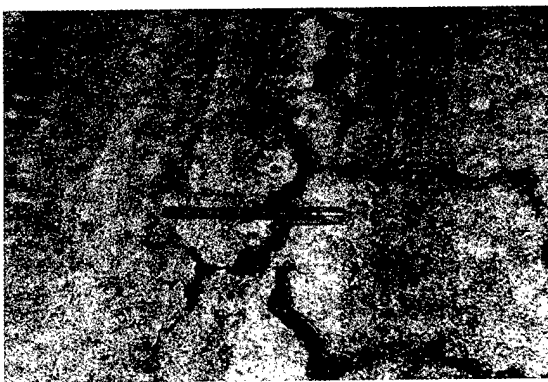
APC, NAS North Island.

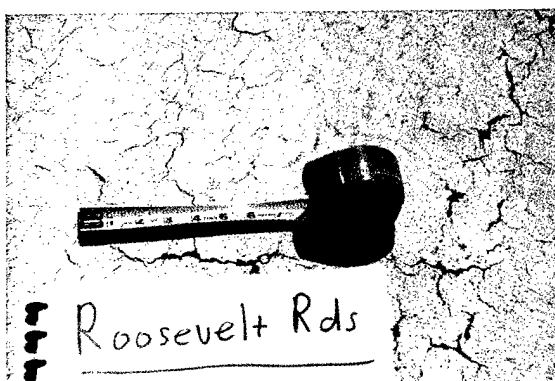
APC, NS Roosevelt Rds.

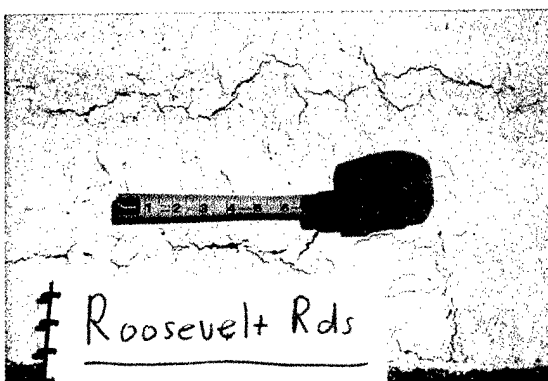
APC, NS Roosevelt Rds.

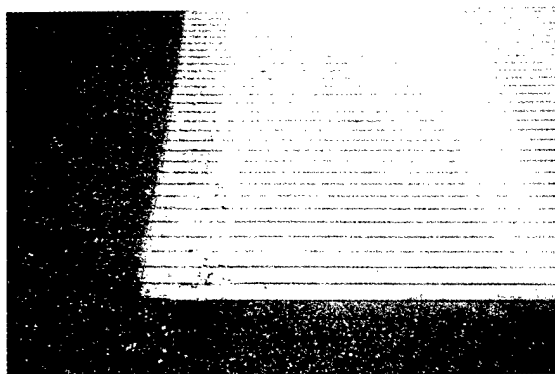
Grooved, friction course
Shreveport Regional.

Shreveport Regional's AC runway contains a grooved, friction course. Grooves are 1/4" wide by 3/8" deep and have been placed transverse at 1.75" intervals. Airfield markings contain a 3.5 year-old coating base and, built-up by overcoating, display an approximate thickness of 50 mils²⁵. The centerline marking was free of APC whereas threshold markings contained microchecked paint (small, hairline mudcracks). Although combinations of waterborne and water-based acrylics are used, APC, as identified on the above three runways, was absent. It appears that the grooved, friction course may have relieved the stresses which generally produce APC.

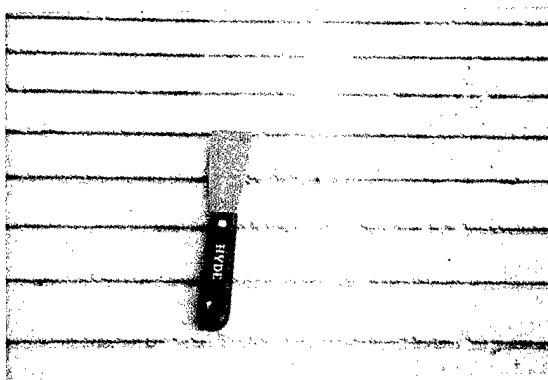
Threshold marking, Shreveport Regional.

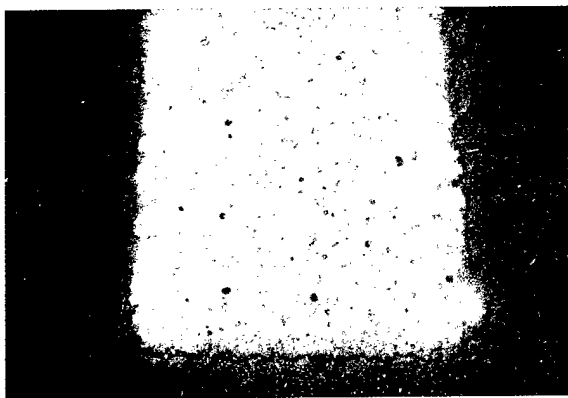
Early stage of edge cracking.

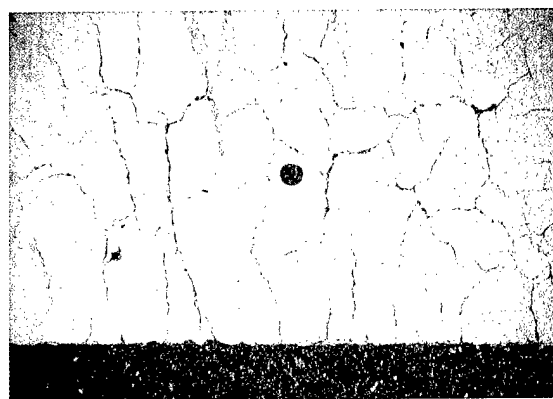
Early stage of APC.

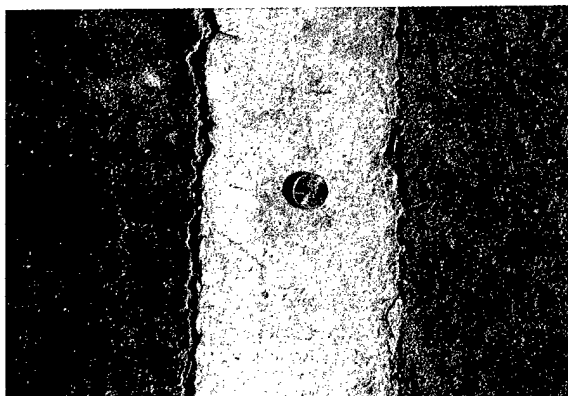
Advanced stage of edge cracking.

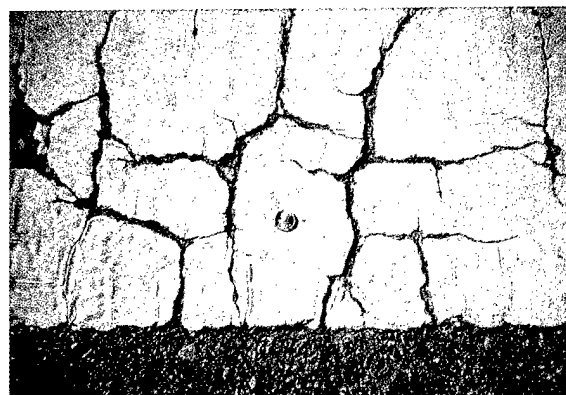
Advanced stage of APC.

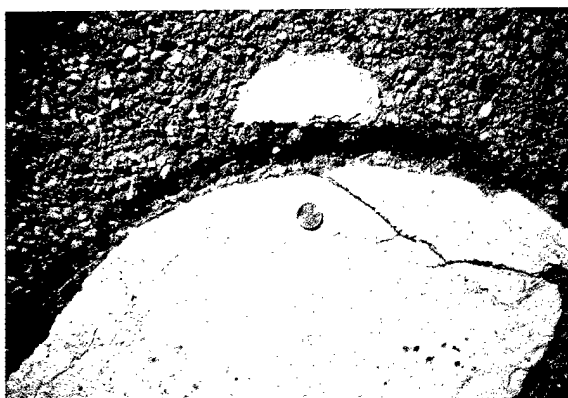
Severe edge cracking.

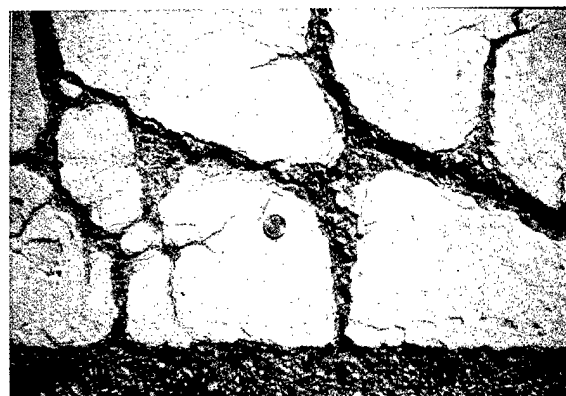
Severe APC.

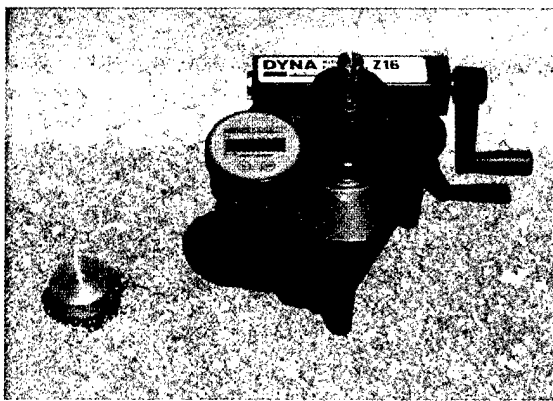
Poceq Dyna Tester and 2" pull-off puck.

The cohesive strength of four Southern California asphaltic wearing surfaces was quantified using a Proceq Dyna Tester and 2" diameter pull-off pucks. Cohesive strength testing was conducted in the field and performed on the following wearing surfaces: A) 4 year-old, 3" thick AC pavement with up to 1/2" coarse aggregate, B) 5+ year-old road SS, C) 1 year-old parking lot SS, and D) 1 year-old parking lot Seal Coat (SC). Asphaltic wearing surfaces are thermoplastic whereby cohesive strength decreases with increasing temperature. Table 1 lists cohesive strengths for the above wearing surfaces tested at various surface temperatures.

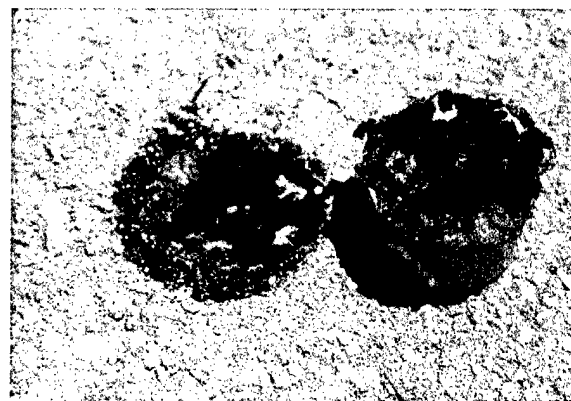
AC cohesive failure: 1/4" of AC attached to pull-off puck.

Cohesive strength values represent the wearing surfaces' maximum tensile strength and, in general, limits marking paint adhesion to asphaltic surfaces. For example, if a marking paint was applied to the above AC surface and tested for adhesion at 108°F: maximum paint adhesion is displayed when the marking paint produces an AC cohesive failure at 106 psi.

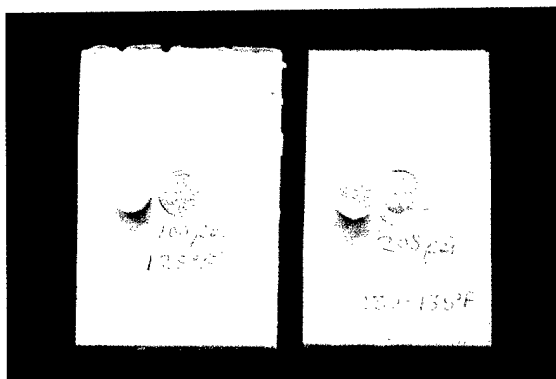
Pull-off pucks and samples with resulting paint cohesive failures.

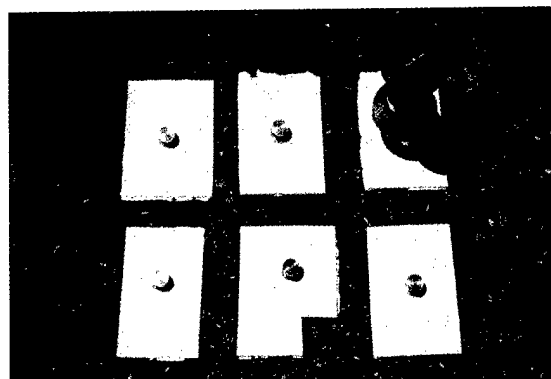
Elcometer adhesion tester and 3/4" pull-off pucks attached to paint samples.

An Elcometer adhesion tester with 3/4" diameter pull-off pucks was used to quantify the cohesive strength of paints. Paints were applied to either grit blasted aluminum or grit blasted steel. Table 2 lists the cohesive strength of paints at room temperature whereas Table 3 lists the cohesive strength of Paints I, II at elevated temperatures.

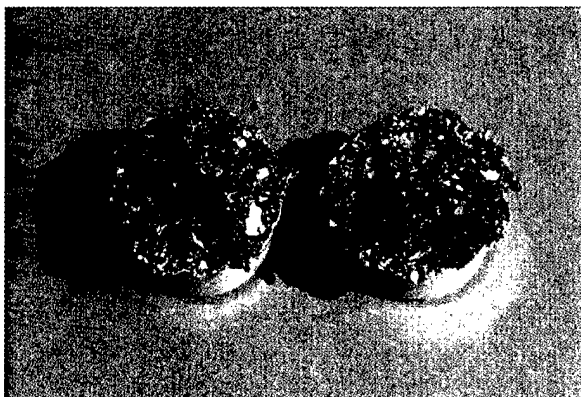
Paint with attached chunks of AC indicate paint adhesion > AC cohesive strength.

Paints were applied to clean AC in one coat at an approximate Dry Film Thickness (DFT) of 10 mils. Paint adhesion was quantified using a Proceq Dyna Tester and 2" diameter pull-off pucks. Table 4 lists adhesion values at a specific AC surface temperature and represents the average of two tests per paint. Each pull-off test produced an AC cohesive failure and results signify maximum paint adhesion to AC. Table 5 lists overcoat adhesion values of Paint I applied over each of the six paints. Results from overcoat adhesion suggest waterborne acrylics develop excellent bonds to previously applied acrylics.

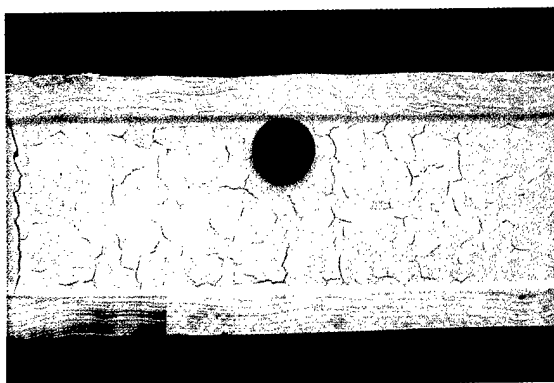
Paint I cracking at > 30 mils DFT.

Paints were applied in one coat at several DFTs to either a Teflon sheet or a metal substrate (aluminum, steel) and observed for the presence of cracks. Paint cracking occurs when the paint's internal stress exceeds the paint's cohesive strength. Table 12 identifies the presence of cracked paint at several DFTs.

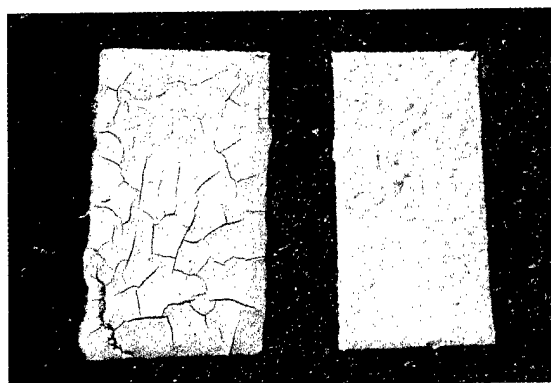
Paint I (left), Paint HB (right).

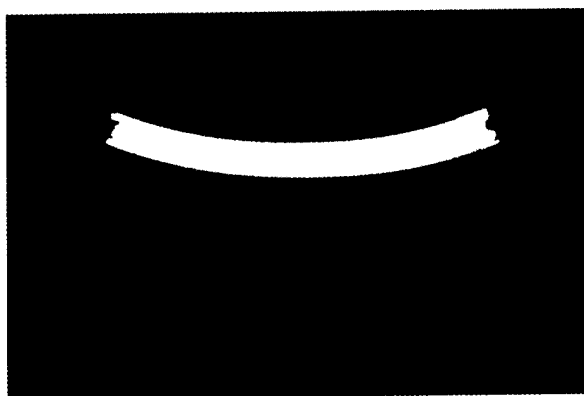
Shim bending technique.

Residual Cure Stress (RCS) was quantified using the freely supported beam method (shim bending technique)^{33,34,35,36}. Paints were applied to stainless steel shims (0.012" x 10" x 2": SS 302) at DFTs \geq 38 mils. The initial shim deflection, prior to coating, was used as the zero point. Equations (1) and (2) are presented in Reference 35 and were used to calculate RCS. Table 13 lists RCS per mil of cured paint.

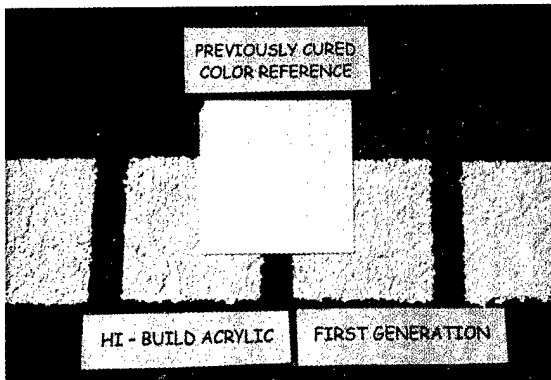
Paints HB, I displayed poor asphaltic bleed resistance.

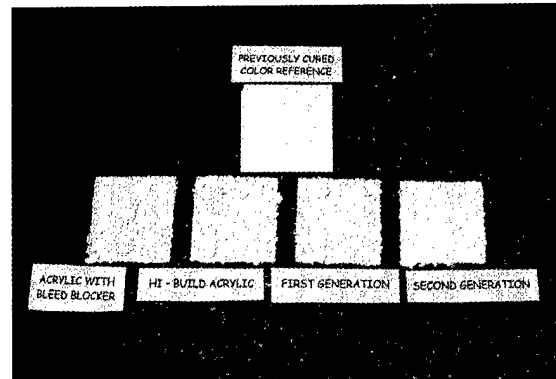
Testing for asphaltic bleed resistance.

Paints were applied to a clean, four-year old AC surface at approximately 10 mils DFT by brush. Table 15 lists qualitative visual results for asphaltic bleed resistance whereby paint EA, doped with an asphaltic bleed-blocking agent, outperformed the acrylic marking paints.

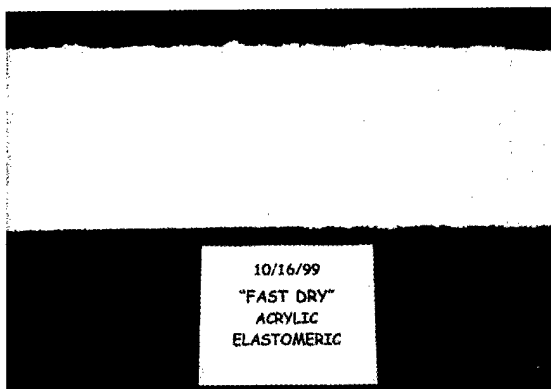
Patch applied to parking lot SS.

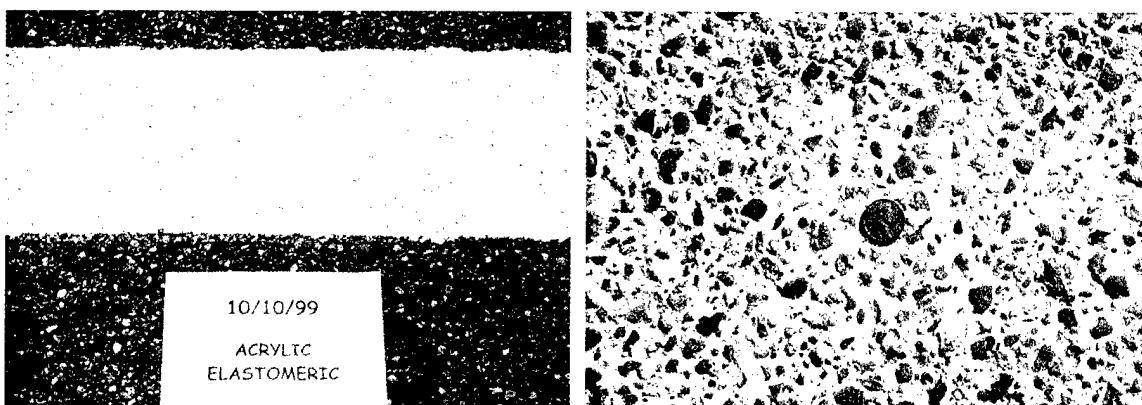
Patch applied as stripe for stop sign.

Poor abrasion resistance at 2 months service: Stop sign stripe.

Two Paint EA patch tests were applied to the following areas located in Southern California at approximately 10 mils DFT: A) Stop sign stripe over AC, and B) One-year old parking lot SS. Patch A was used to evaluate abrasion resistance whereas Patch B was used to evaluate the effects of both RCS and short-term thermal cycling. Adjacent Patch B, the parking lot SS displayed a cohesive strength of 18.5 psi at 103°F and previously applied marking paints contained significant edge cracking. At two months service, patches were evaluated for performance. After approximately 20,000 car passes, Patch A displayed poor abrasion resistance whereby previously coated high spots had failed. Patch B, however, was not subjected to automotive traffic and remained crack free (0 % edge and internal cracking). Results validate the following Paint EA properties: 1) Poor abrasion resistance, 2) Low transfer of RCS to substrates, and 3) Flexibility sufficient to combat thermally induced SS movement.

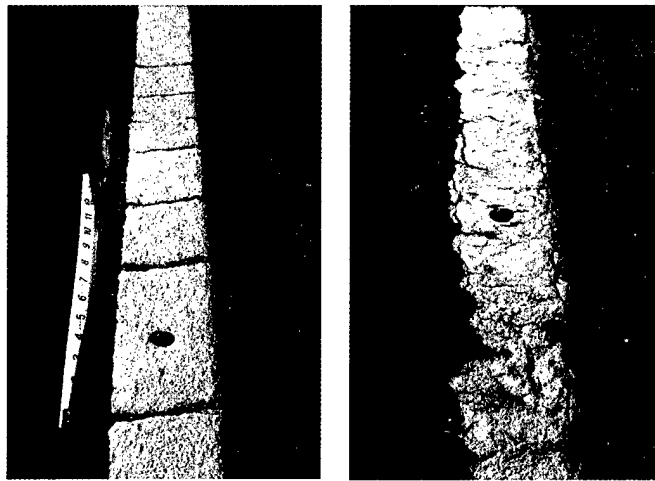
Stripes were applied at the same time: right stripe receives sprinkler runoff.

Moisture induced stress occurs when coatings absorb moisture from rainfall, high humidity, dew, and pavement moisture vapor emission. Cycling between water absorption (volume increase) and drying (volume contraction) increases cohesive and adhesive paint stress. As previously noted, the tested paints displayed water absorption weight increases ranging from 5.5 % to 12.6 %. In general, a 10 % increase in weight represents approximately a 13 % increase in volume⁵⁰. Paints I, II displayed approximately a 10 % weight increase from water absorption and, since they also displayed poor flexibility, should weather poorly when subjected to high levels of moisture. As evident in the above photographs, high levels of moisture accelerate acrylic marking paint failures.

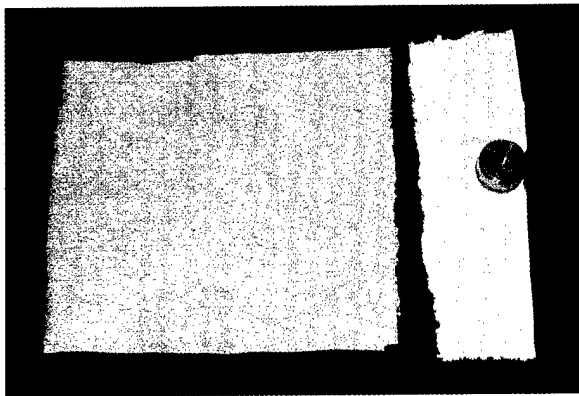
The above flexible acrylic was lifted in sheets, using hand pressure, from a concrete substrate.

Flexible acrylic marking paints designed for asphaltic pavements must contain the appropriate level of tensile strength, adhesive strength, and percent elongation. If coating/substrate adhesion is well below the coating's tensile strength and the paint contains a high percent elongation, the marking paint may fail in sheets when subjected to various stresses. The above photograph shows a flexible coating which developed an adhesive strength of 70 psi to concrete and, as a result of a high percent elongation ($\geq 300\%$) and a high tensile strength (≥ 300 psi), was pulled off the concrete in sheets. Ideal properties for semi-flexible marking paints are presented in Table 18 below.
